Manhole Inspection Summary

Manhole # S2111_018MH

Location Address: **2908 hollins ferry rd**

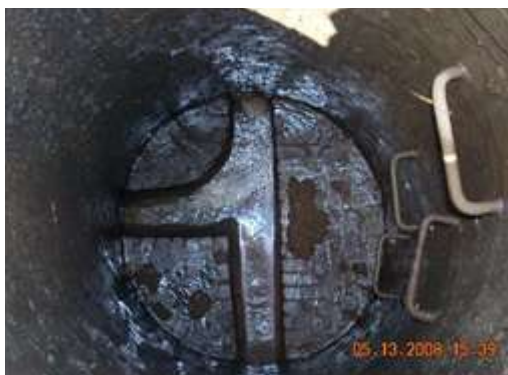
Misc

Bench Debris

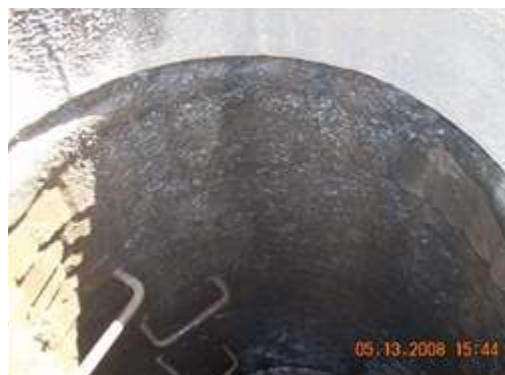
Defect 4

Infiltration: ☐ None ☒ **Joint** ☐ Cracks ☐ Mortar ☐ Roots ☐ Wall

infiltration @ chimney/frame joint

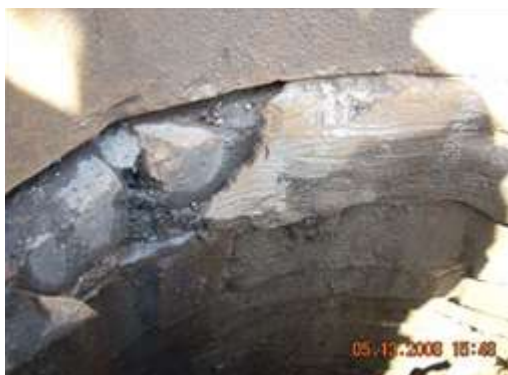
Defect 3

Condition: ☐ Sound ☒ **Cracked** ☐ Root Intrusion ☐ Loose Brick ☐ Deteriorated

cracked chimney brick

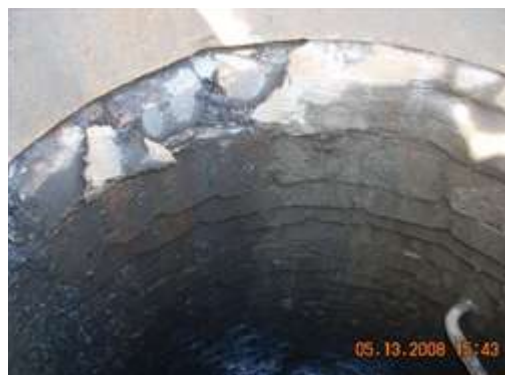
Defect 2

Infiltration: ☐ None ☒ **Joint** ☐ Cracks ☐ Mortar ☐ Roots ☐ Wall

infiltration @ chimney/corbel joint

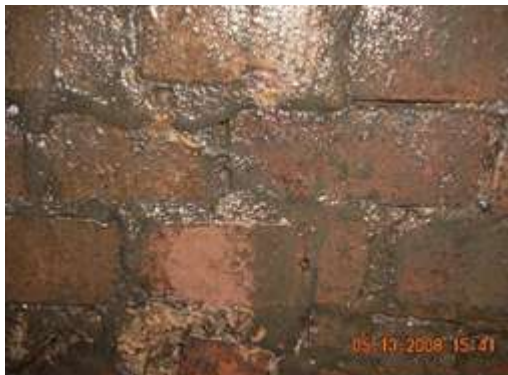
Defect 1

Infiltration: ☐ None ☒ **Joint** ☐ Cracks ☐ Mortar ☐ Roots ☐ Wall

infiltration @ barrel wall

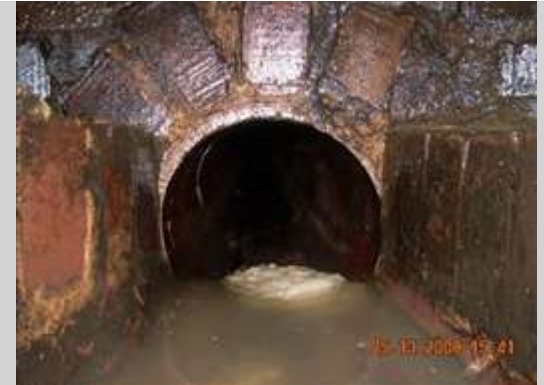
12 O'Clock Outflow

Pipe Height: **8.4** (in.) Rod and Bar (Angled)
Pipe Material: **Clay** ☐ Pipe Lined
Invert Depth: **8.84** (ft.) Flow Characteristics: **Slow**
Deposits: ☐ None ☐ Mud ☒ **Sludge** ☐ Debris ☐ Grease
Silt Depth: **1** (in.) Deposits Extent: **Light**
Infiltration: **None** Pipe Seal Cond: **Sound**
